INDOOR AIR QUALITY ASSESSMENT

**Tile Investigation
Friedman Middle School
500 Norton Avenue
Taunton, Massachusetts**

Prepared by:
Massachusetts Department of Public Health
Bureau of Environmental Health Assessment
Emergency Response/Indoor Air Quality Program
January 2003

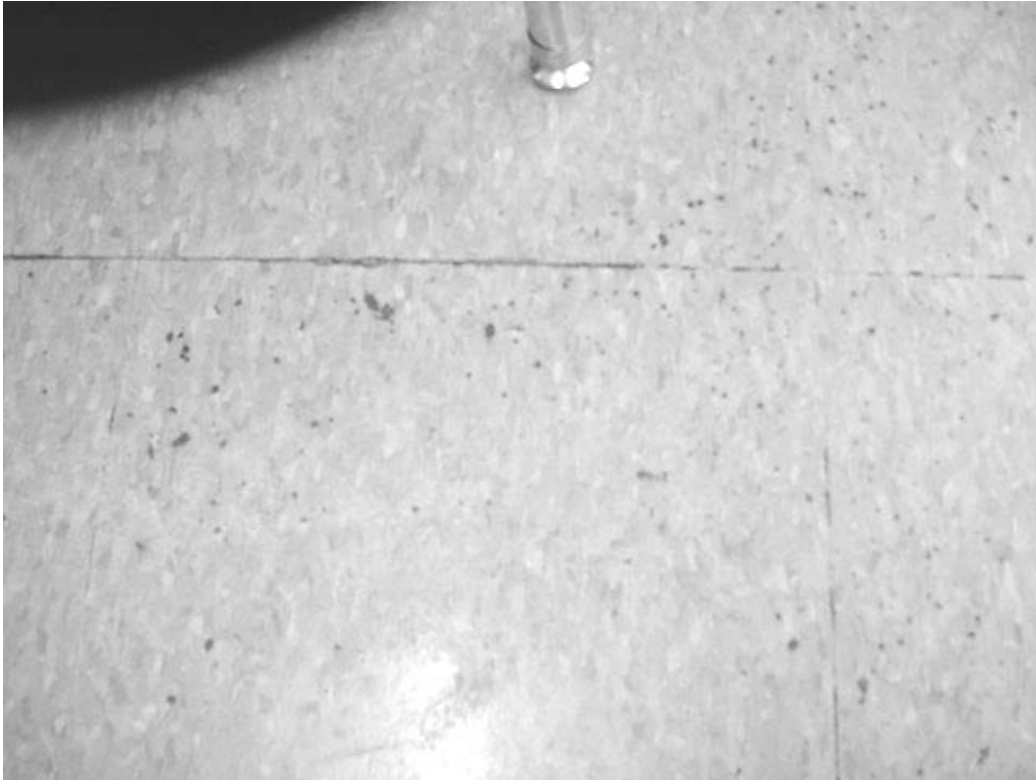
Picture 1

As previously discussed, the assessment was requested due to occupant concerns of stained floor tiles believed to be possible mold growth. BEHA staff examined stained tiles throughout the first floor of the FMS, which appeared to be a gum-like substance

rather than staining (see Picture 1). The material accumulated on tiles did not appear to be microbial growth and no mold-type odors were detected (or reported by school/health officials). Accumulations appeared to be more prevalent in high traffic areas and classrooms than in low traffic areas (e.g. the art room, teacher's workroom and science lab). Stained tiles also appeared to be more prevalent in specific areas that had excess mastic leaking/oozing from around tile seams (see Picture 2).

Gum-like Substance on Floor Tiles as Indicated by Dark Spots

1. Contact the tile manufacturer to get the best advice on how to remove staining/material and dry out moisture from beneath tiles. This may include:
 - Removing material by stripping off wax with a buffer.
 - Allowing tiles to dry out either naturally, by heat or with dehumidification, or possibly (low relative humidity during the heating season should facilitate drying).
 - Removing and reapplying water damaged tiles.
2. Consider removing several tiles in various areas to determine if visible moisture and/or microbial growth are present. If so, the removal of all affected tiles may be necessary followed by cleaning with an appropriate antimicrobial agent.

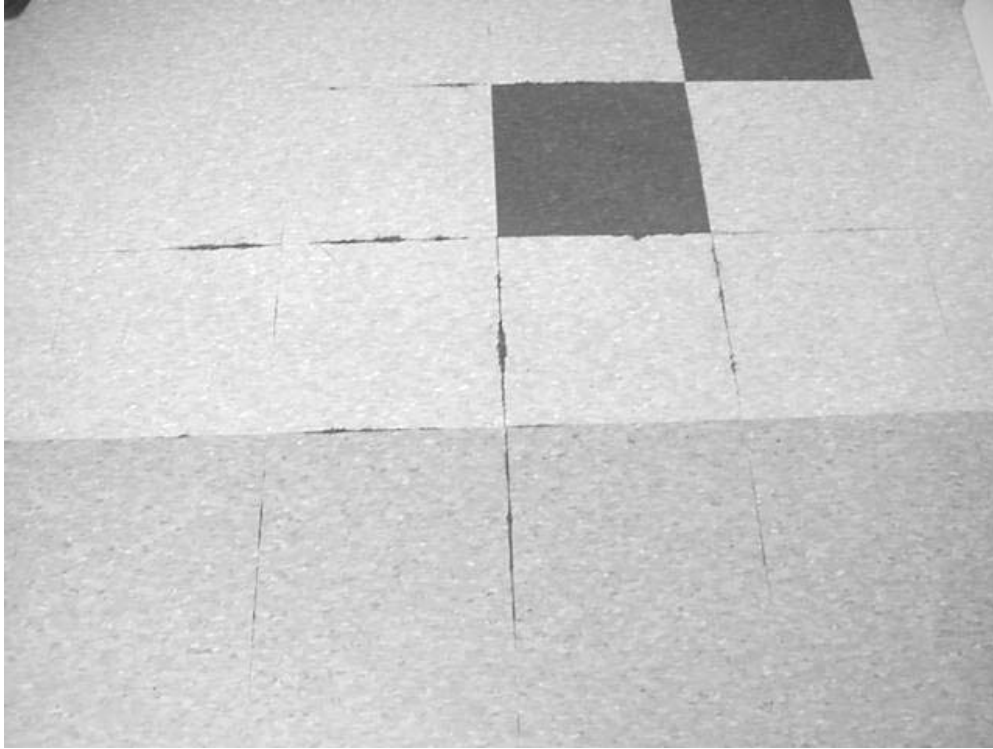
Picture 2

Gum-like Substance Observed around Floor Tiles

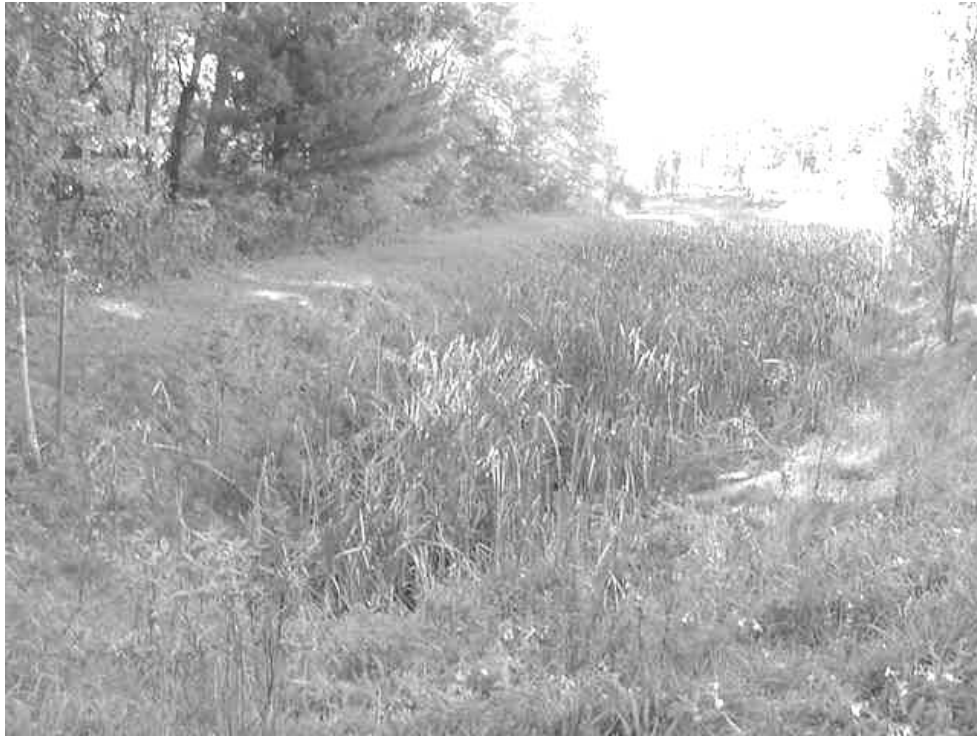
Picture 3

- Water penetration from ground water through the slab beneath tiles is unlikely due to:
 - The water table reported by school and health officials is at least 8-10 feet below the slab of the building. The water level observed in an adjacent wetland was well below the slab level of the building (see Picture 3).

**Adjacent Wetland located down hill from the Friedman Middle School, Note Water Surface
Approximately 8-10 feet below Grade of School**

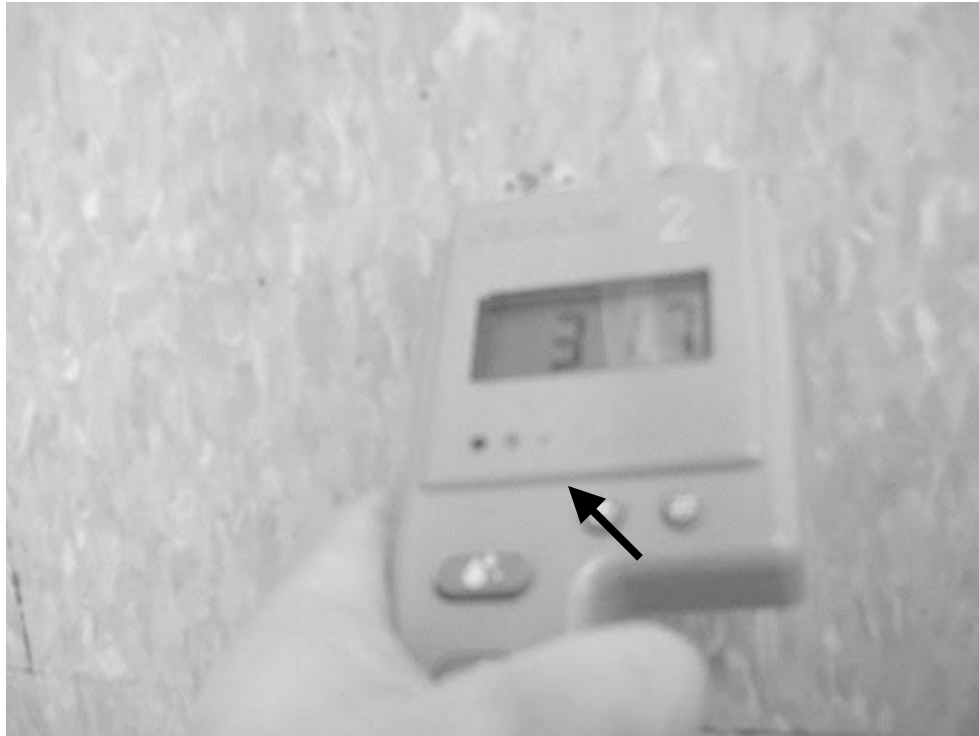
Picture 4

To determine if affected tiles had higher moisture content compared to unaffected tiles, moisture tests were conducted. As described earlier in the **Methods** section of this report, the tips of a moisture detector probe were inserted into stained and clean tiles (see Pictures 4 & 5). Tiles that were stained had consistently higher moisture content than those that were not (see Tables). In classrooms where the material had been removed, the

Moisture Detector Inserted Into Stained Tile, Note Red Indicator Light was on Indicating High Moisture Content (Reading = 31.7 Percent)

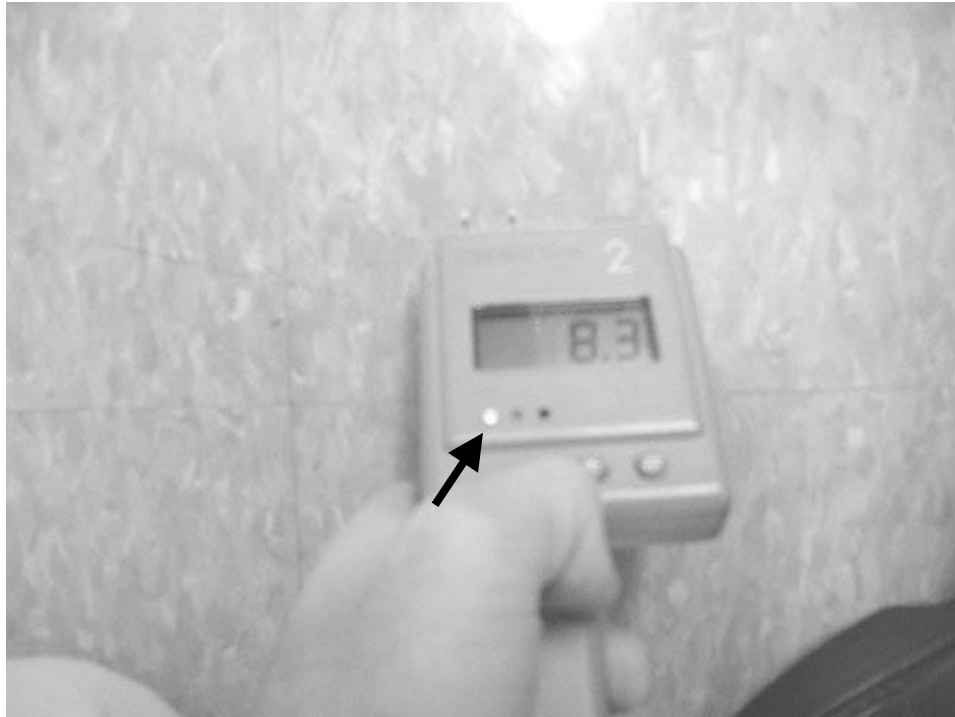
Picture 5

Moisture Detector Inserted Into Unstained Tile, Note Green Indicator Light was on Indicating Low Moisture Content (Reading = 8.3 Percent)

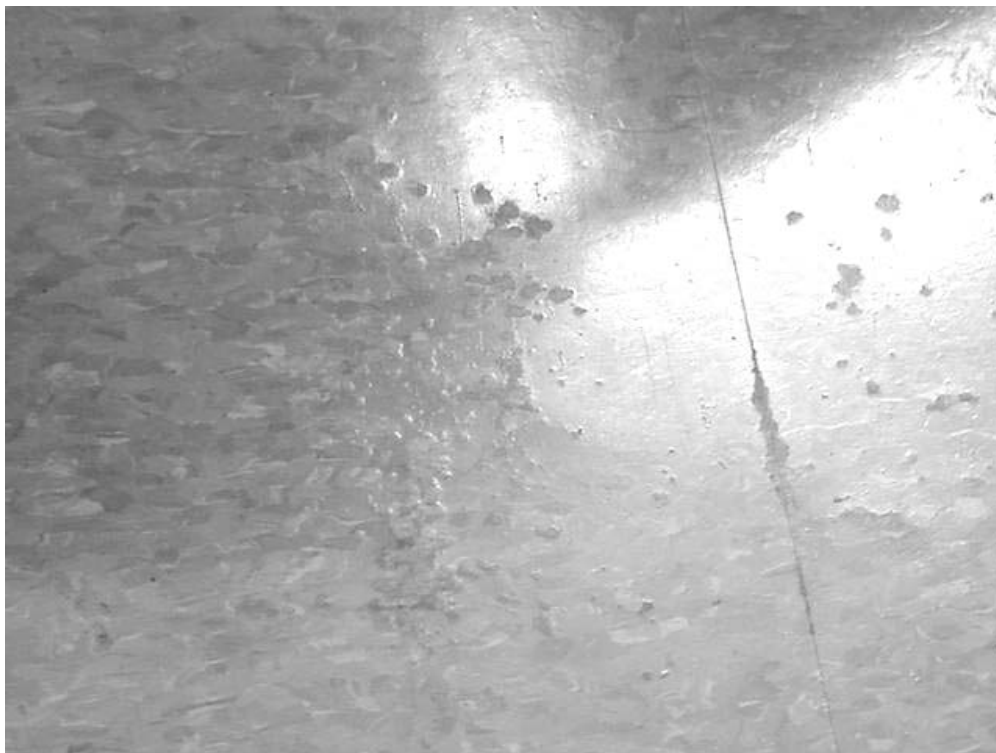
Picture 6

tile surface where stains had previously been had a spotty appearance (see Picture 6), indicating likely water damage.

Mottled Surface of Floor Tile That Had Stains Removed
